BIG-BOX RETAIL CENTER  
RETENTION POND RESTORATION  
AUGUSTA, GEORGIA

2019 CASE STUDY

# MOSQUITO INFESTATION LEADS TO SHORELINE RESTORATION, ENVIRONMENTAL REPAIRS

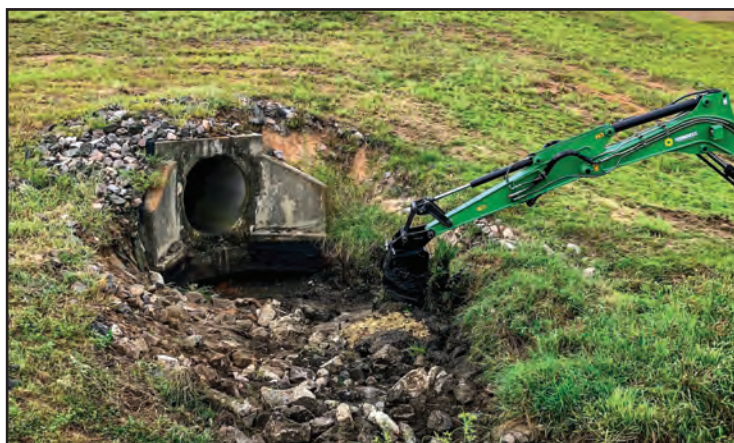
Big-box out flow culvert pipe is damaged from years of high capacity storm water run off.

1. Collapsed shorelines along the retention pond resulting from years of torrential rainfall
2. Compromised and damaged outflow culvert due to constant water pressure and collapsed shorelines
3. Accumulated sediment at the mouth of the culvert resulted in stagnant water, preventing water flow into the pond and causing invasive vegetation growth and algae.
4. The pond's water level was raised due to sediment accumulation resulting in reduced pond depth
5. Increased size of the pond's surface area and water volume due to collapsed shorelines

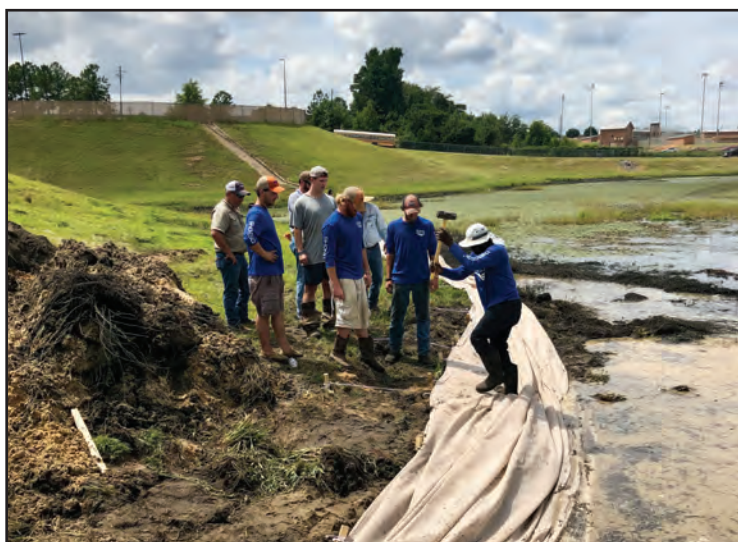
The SOX material is laid out and the staking system is pounded in place.

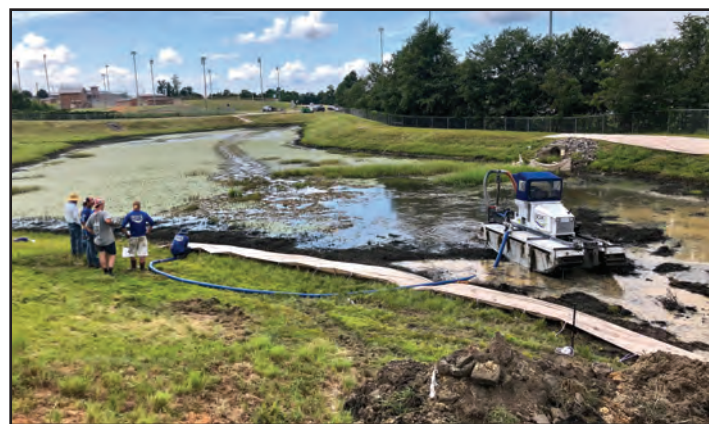
Using an amphibious work boat, pond sediment is dredged into the SOX system to stabilize the shoreline.

The shoreline restoration started with the installation of DredgeSOX, a long-lasting and eco-friendly erosion-control technology. It is also an effective way to remove sediment from waterways and reclaim shorelines that complies with all Best Management Practices of "Living Shoreline" restorations.

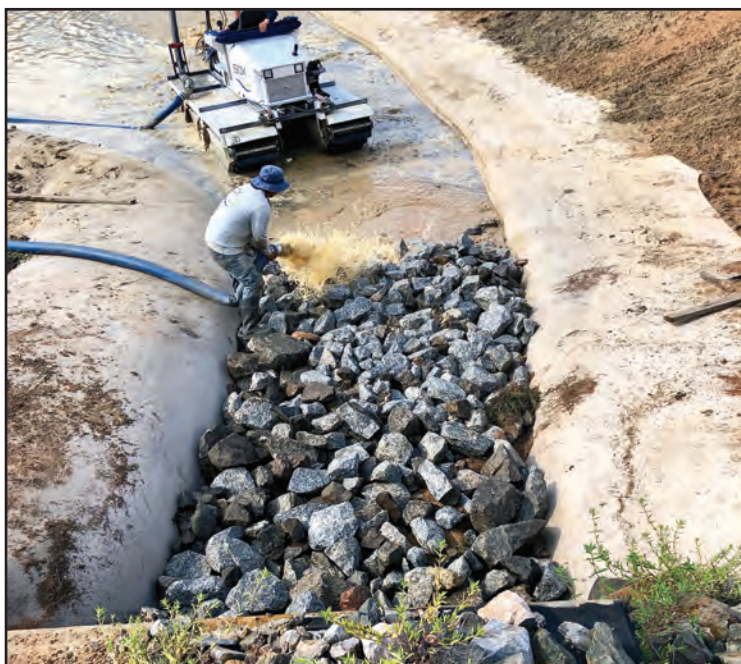
A combination of dredged sediment and excess fill from the project fills the SOX system and then secured by pound the staking system subsurface.

Once filled with sediment, the DredgeSOX material is secured to the shoreline. Sod and other landscaping is planted and then roots through the knitted mesh, creating a long-lasting, living shoreline.
